Reconstruction Finance Corporation Arizona Records

Surface and Underground Workings

of the Gunsight Mine

Reconstruction Finance Corporation
Mining Division
Report of Supervising Engineer

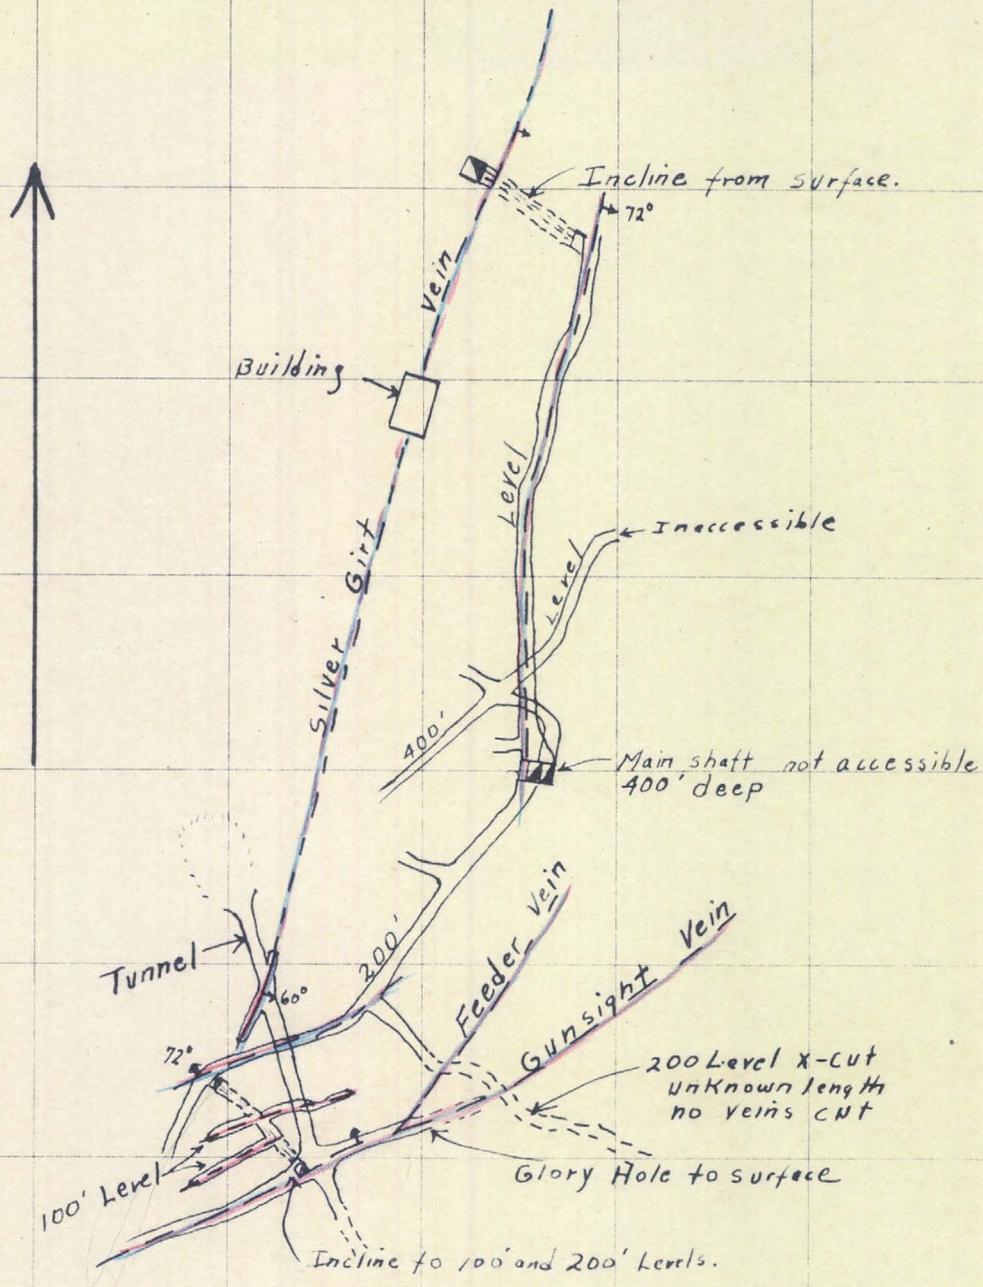
(a) attached to this report are two maps, one is a composite of the underground workings, and the other contains the ^{separate underground} workings showing the position of samples and the assay values. This map is somewhat similar to the one submitted by the applicant.

<u>Sample NO</u>	<u>Ag oz</u>	<u>Pb %</u>
Applicant No 1 41"	9.6	15.72
A check sample was not taken because of the short distance to the surface.		
Applicant No 2 46"	3.2	30.18
R.F.C No 2 22"	0.9	3.11
R.F.C No 3 52"	1.3	1.40

The above samples were taken where galena showed in the vein. It can be seen that there is a wide discrepancy in the lead content of the samples. There were possibly one or two other places in the mine where galena showed, but like the places sampled, the galena was in narrow stringers and was not continuous. It must be concluded that there are no ore reserves in this mine.
